# CHANGE NOTICE

**Effective Date:** OCTOBER, 2009  
**Log Number:** CN-09-415  
**Part Description:** CAM TIMER  
**Model Affected:** ALL LOW TEMP MACHINES

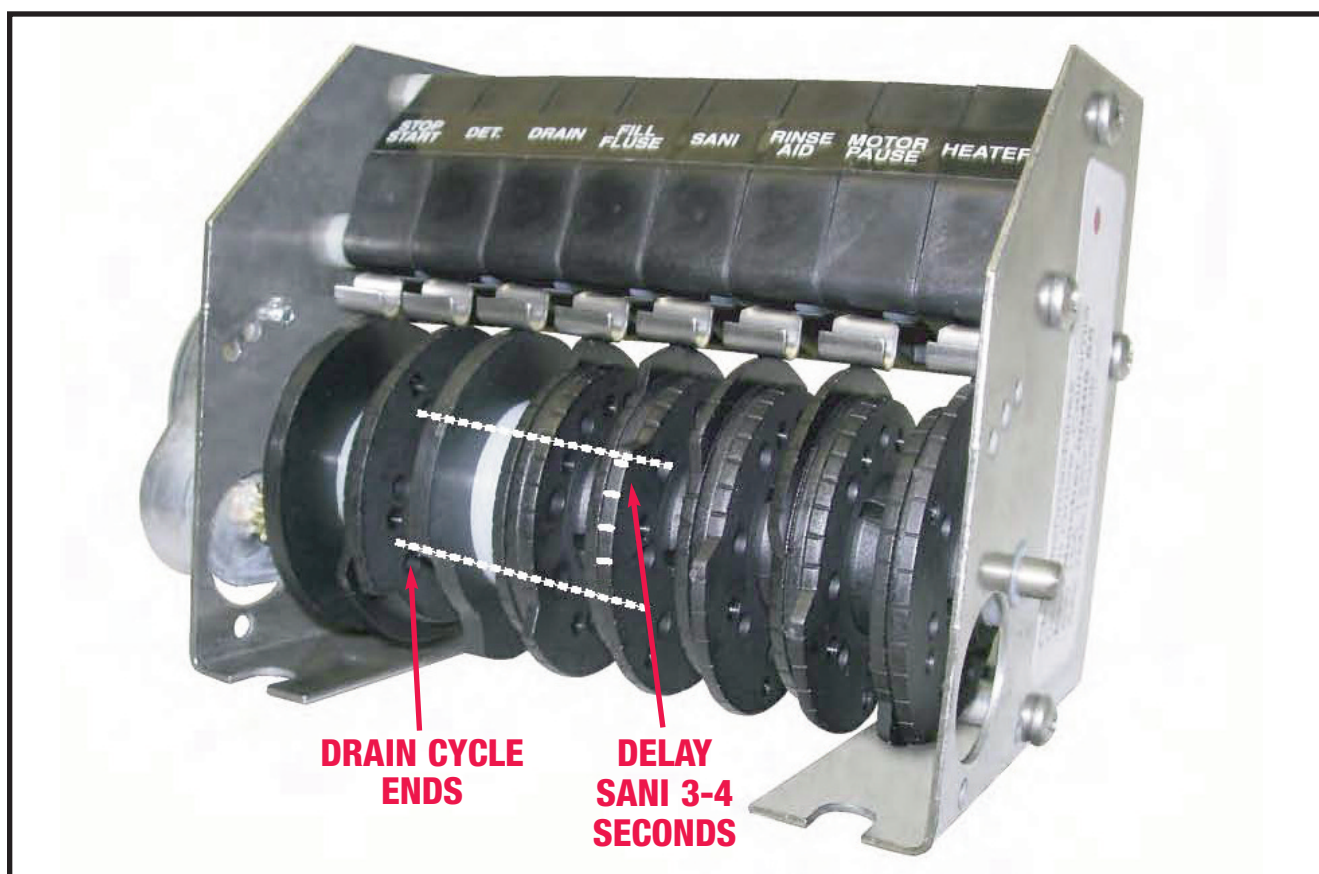
## **SANITIZER CAM**

The Sanitizer Cam has been secured (glued) in position to prevent the sanitizer from being injected too early into rinse cycle. The 3-4 second delay will assure water has entered the tank preventing sanitizer from coming in direct contact with wash tank.
