PRODUCT ENHANCEMENT

Subject: Leaking sanitizer chemical injection point

EST - AH / C / 3 Door / EST-VL
Dishwasher

EST CHEMICAL LINE RETROFIT KIT INSTRUCTIONS PN00790.00

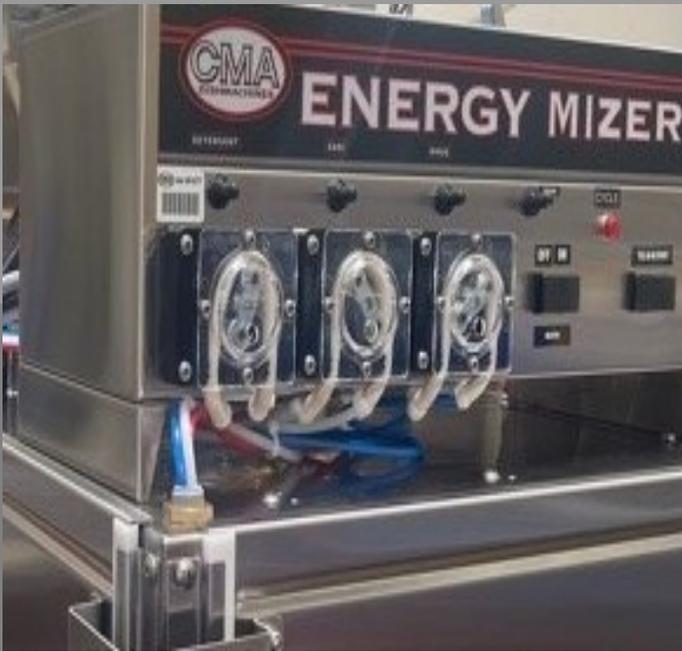
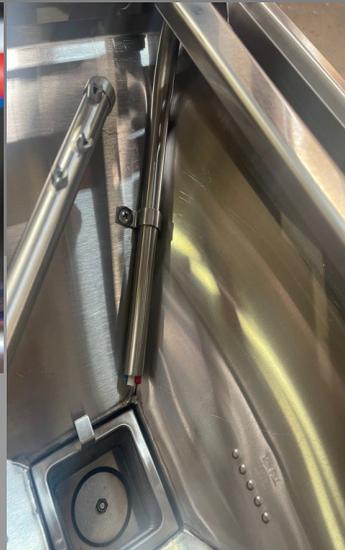
EST-VL

Chemical Line single injection

We moved the sanitizer chemical line (and the detergent and rinse additive too!) to the top of the wrapper and through a single stainless steel tube to the top of the sump.

The single injection point is easier to maintain, visually inspect and repair as needed.

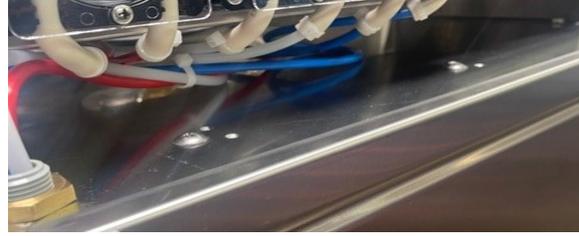
Sanitizer line before and plugged

Detergent and Rinse Additive holes plugged

1. Remove chemical lines from squeeze tubes to injection fittings. CAUTION; Use proper Personal Protective Equipment (PPE) due to chemical in the lines.
2. Plug Sanitizer hole in Sump with included plug. Plug Detergent and Rinse Additive holes with included hardware.

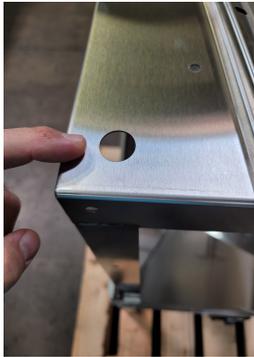
7/8" hole

3. Drill pilot hole 1 1/2" from front left corner on top of wrapper, see picture.
4. Use step bit or metal knockout hole punch to increase hole size to 7/8".
5. Insert stainless steel tube into compression fitting and tighten.
6. Insert the compression fitting with stainless steel tube through the hole from inside the machine.

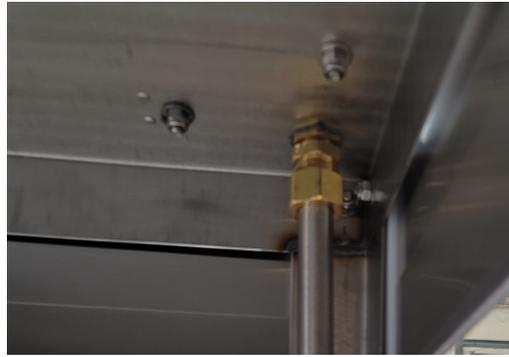
Compression fitting with stainless steel tube

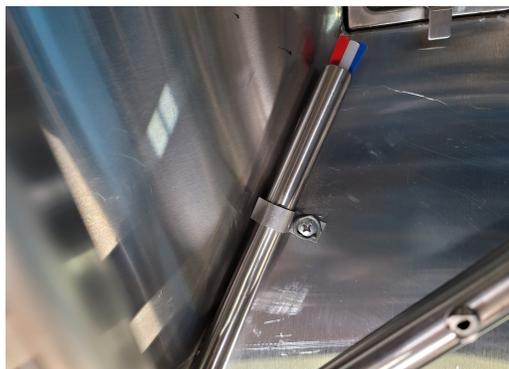
Clamp on stainless steel tube

7. Place clamp on tube and mark to drill hole through the pan.
8. Drill clamp hole.
9. Bolt clamp through the pan with included hardware.
10. Insert chemical lines through the installed tube from the top till chemical lines extend from end of stainless steel tube towards sump. Attach chemical lines to squeeze tubes and prime lines.

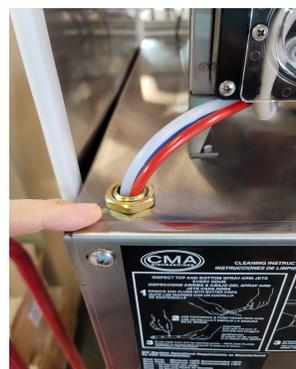
Chemical lines through new tube
